BOISE VENEER
400 SOUTH 1ST STREET, ST. HELENS, OREGON
PHASE I ENVIRONMENTAL SITE
ASSESSMENT

Prepared for
CITY OF ST. HELENS

June 29, 2015
Project No. 0830.01.01

Prepared by
Maul Foster & Alongi, Inc.
2001 NW 19th Avenue, Suite 200
Portland, Oregon 97209

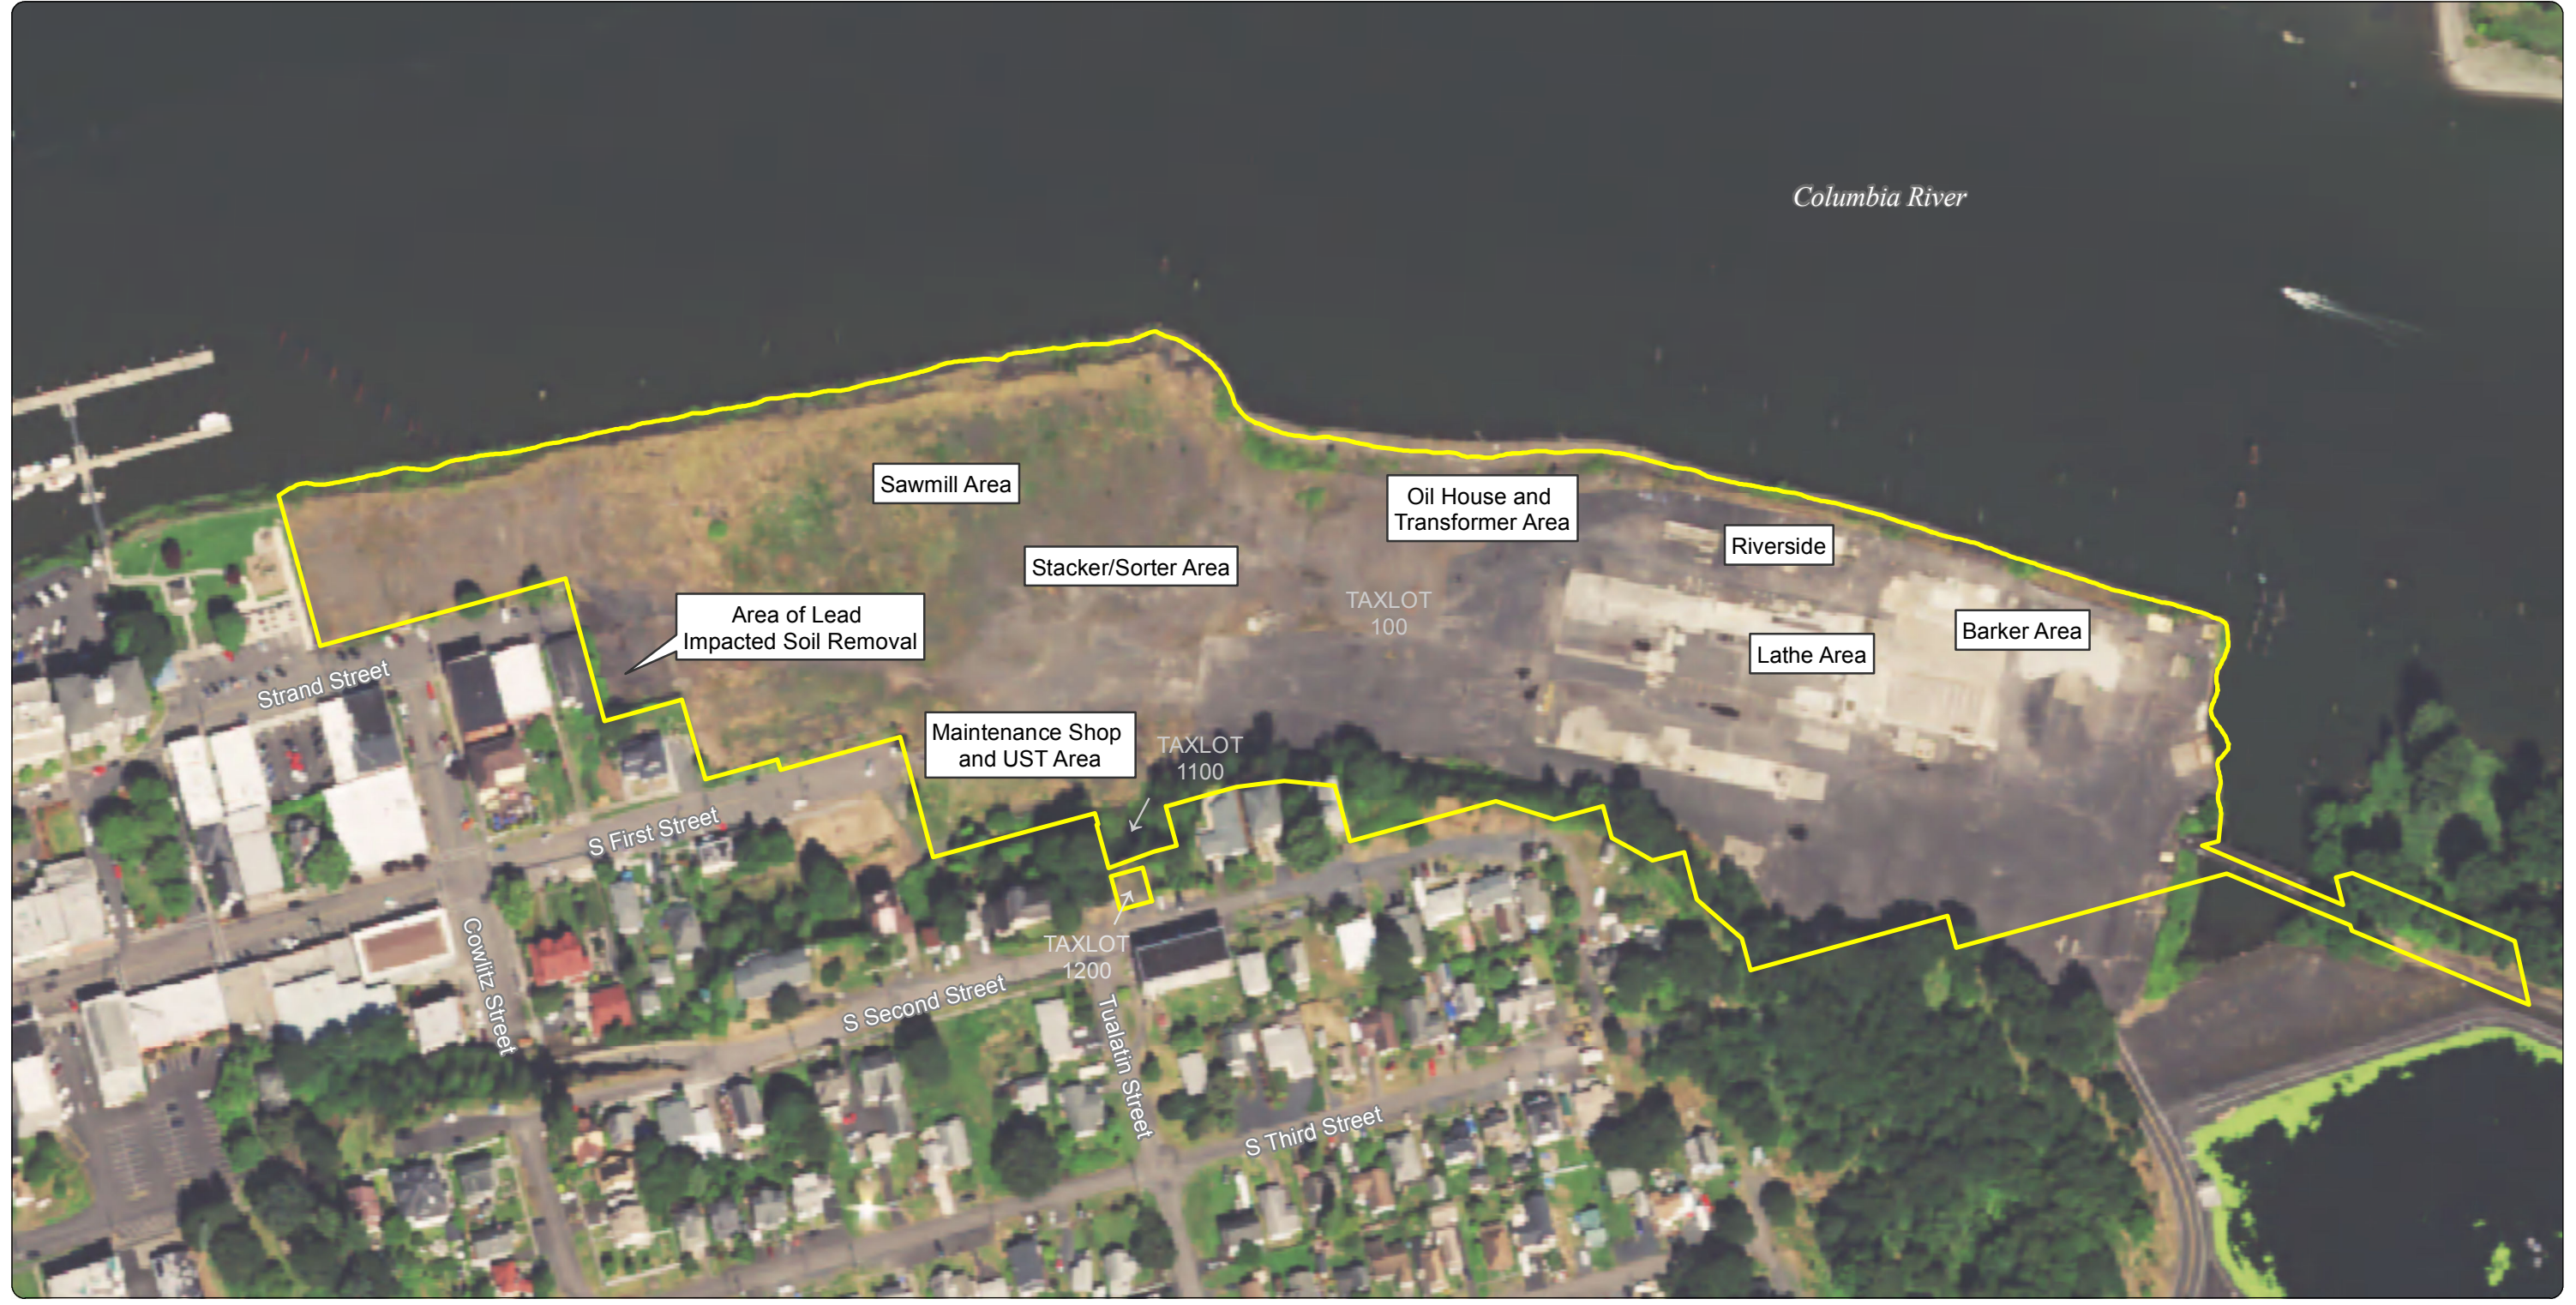
The CRECs identified through completion of this Phase I ESA are noted below and are discussed in further detail throughout this report. Figure ES-1 displays the area names used to describe different portions of the Property.

Source: Aerial photograph (2014) obtained from the National Agriculture Imagery Program (NAIP).
Note: All site features are approximate and historical. OHW = Ordinary High Water.

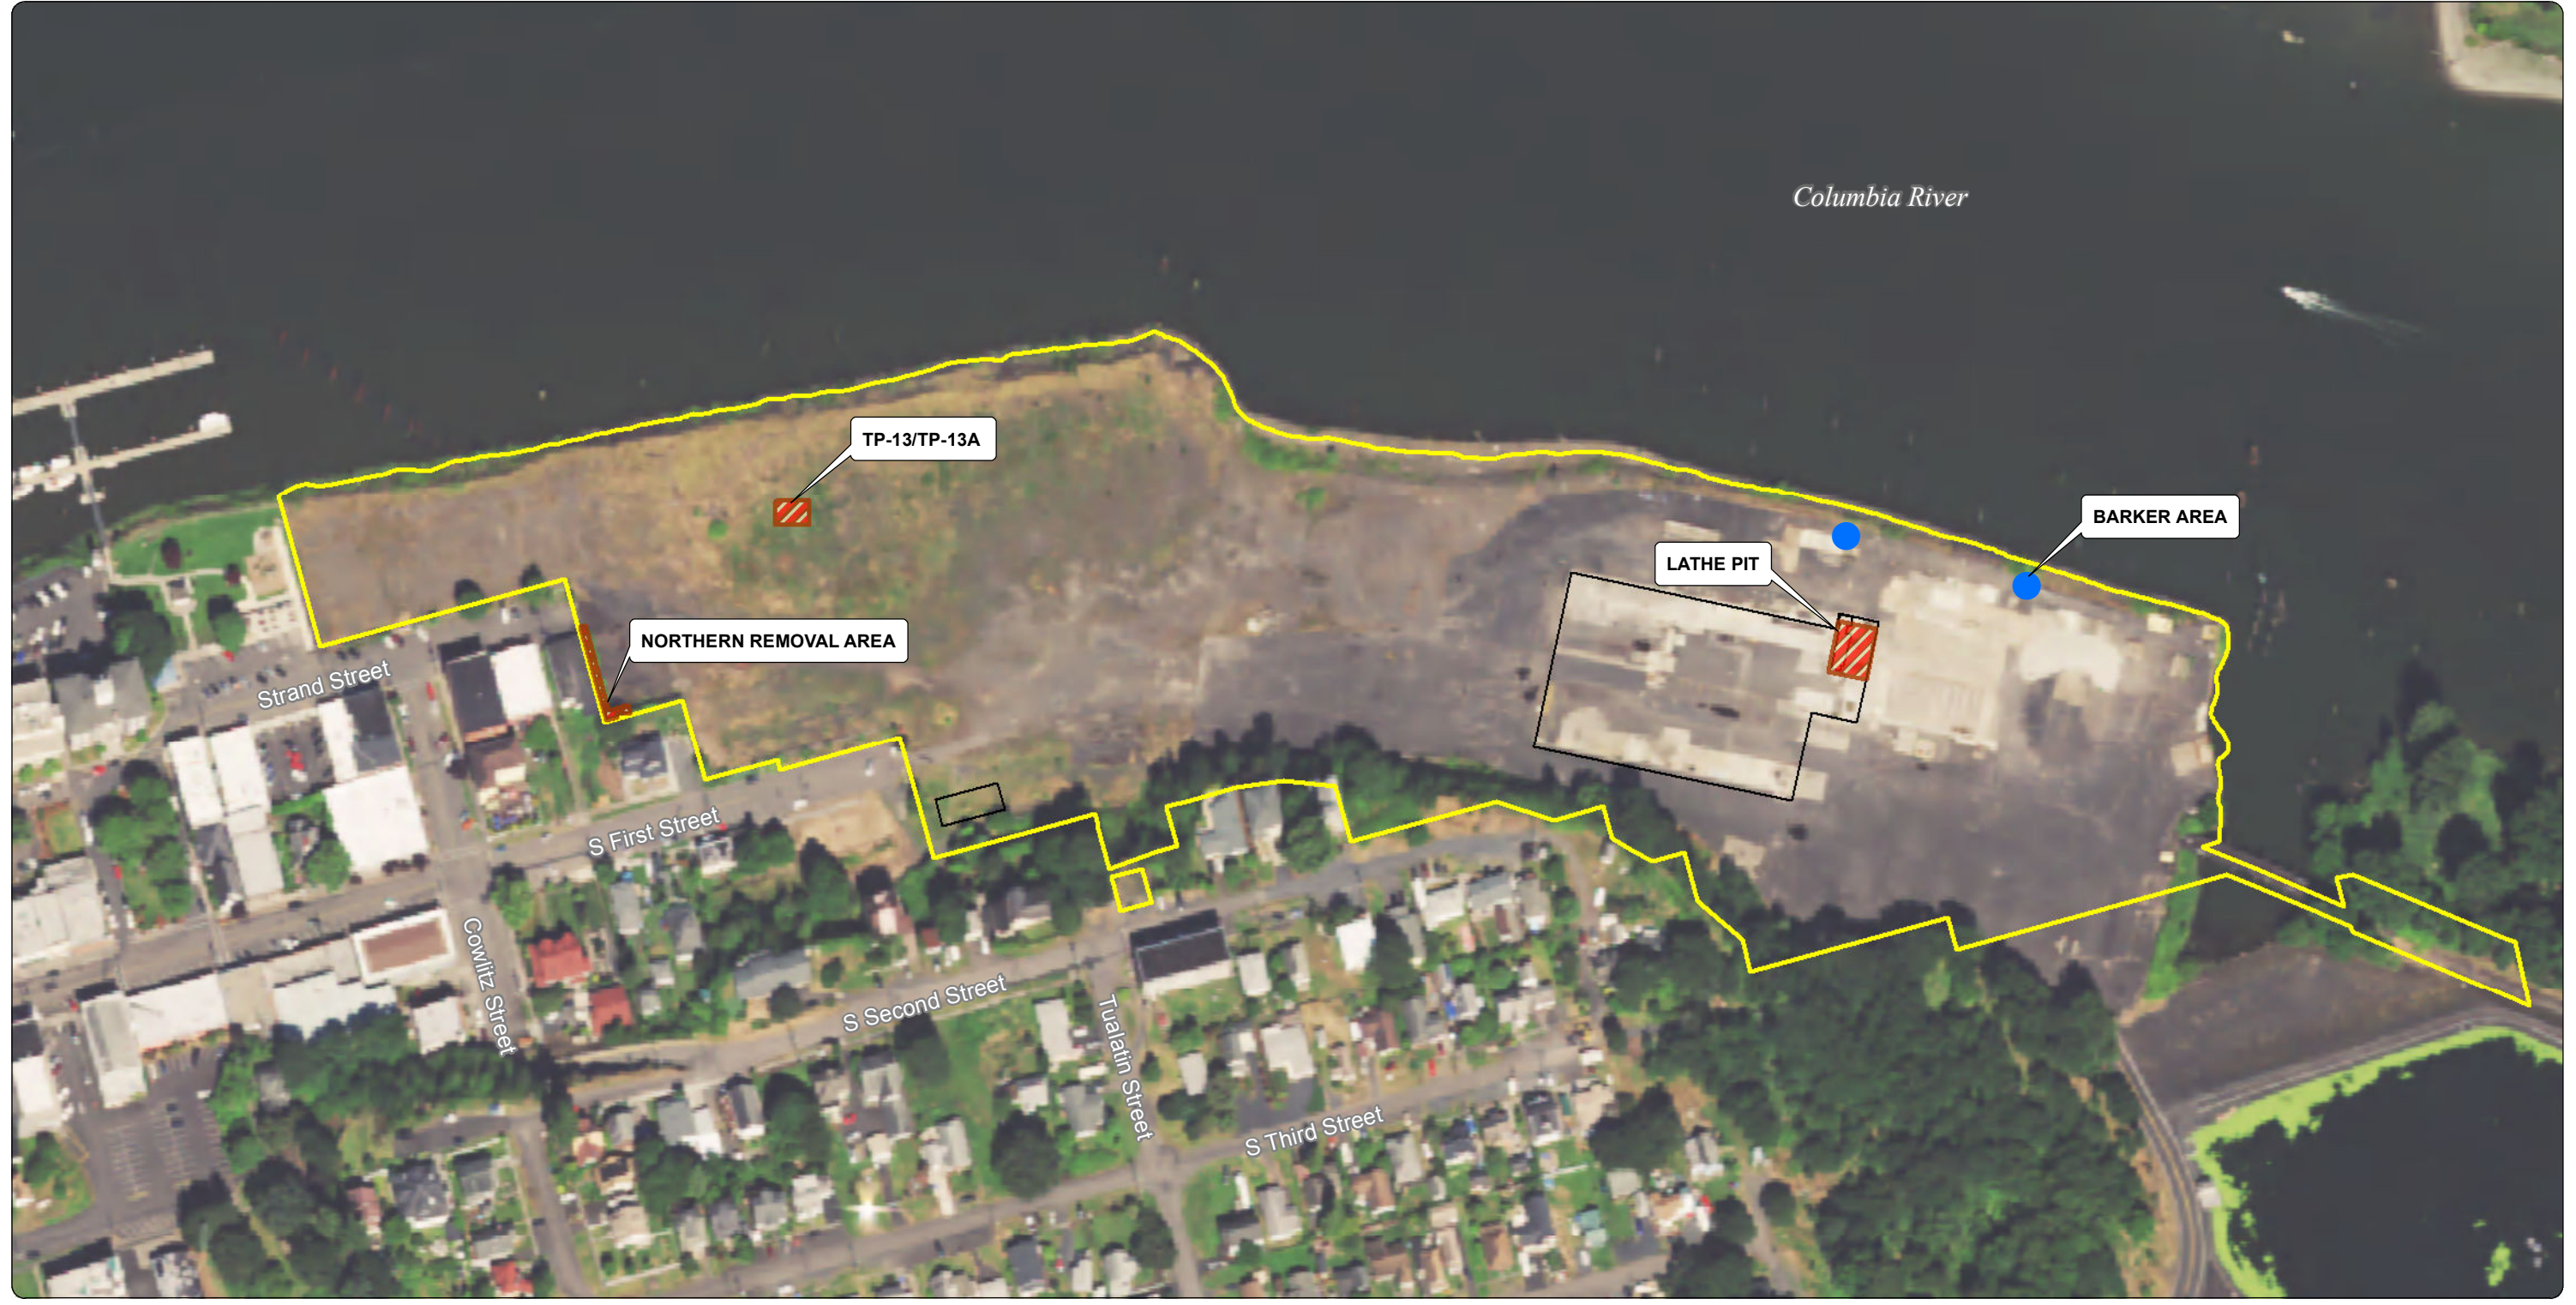
Figure 3 Restricted Areas

Areas of concern (also referred to as “restricted areas”) of the Property as identified in the CMMP (MFA, 2015) are depicted on Figures 3 and 4.

the forthcoming Easement and Equitable Servitudes in relation to impacted soil from the former lathe is depicted on Figures 3 and 4.

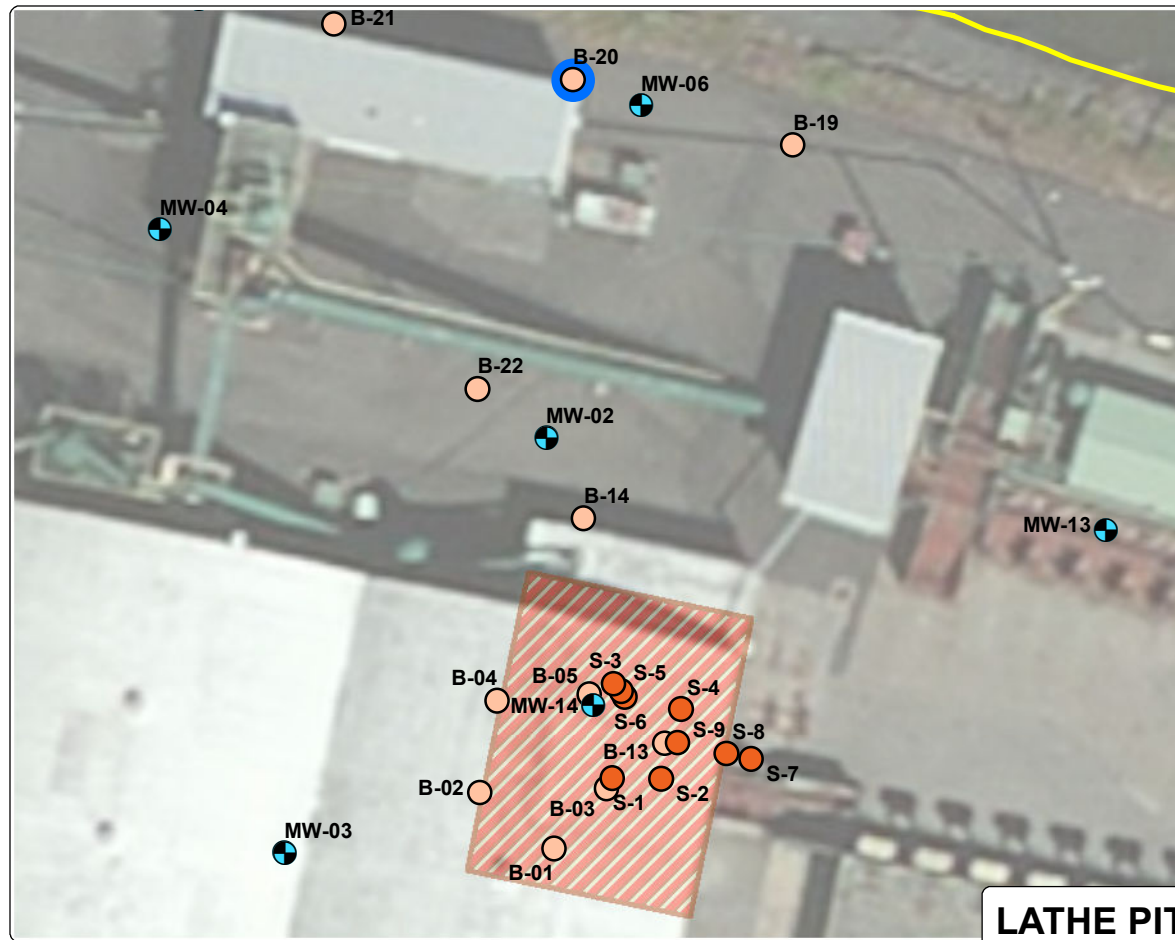
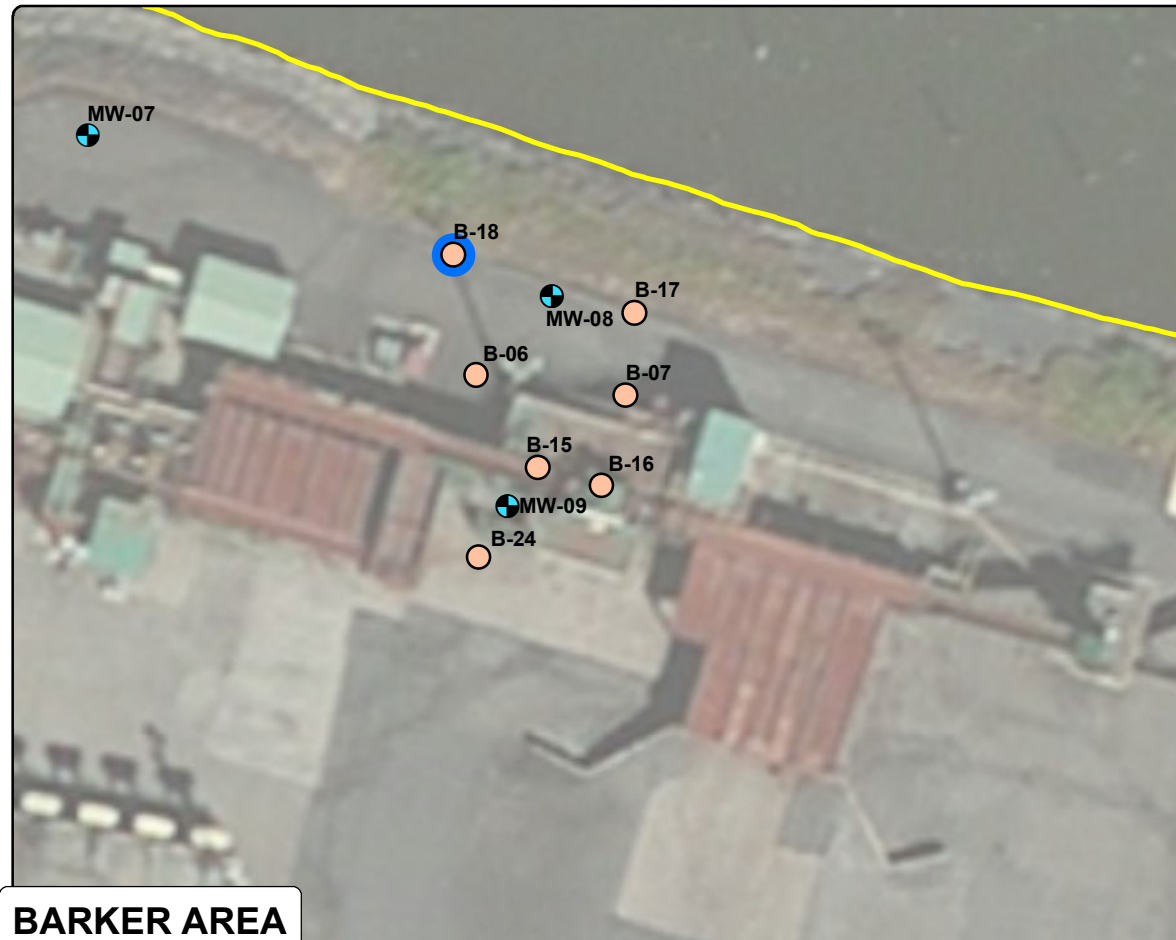
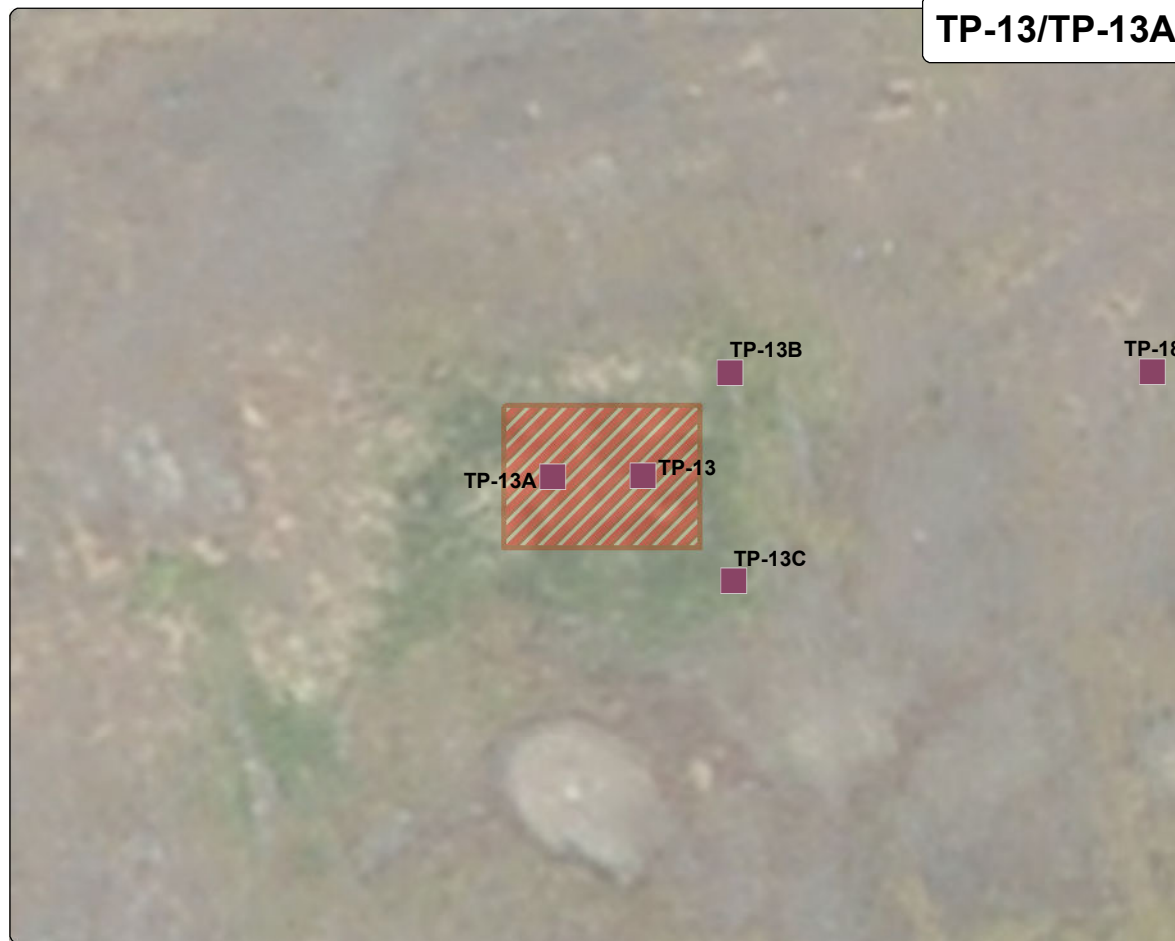
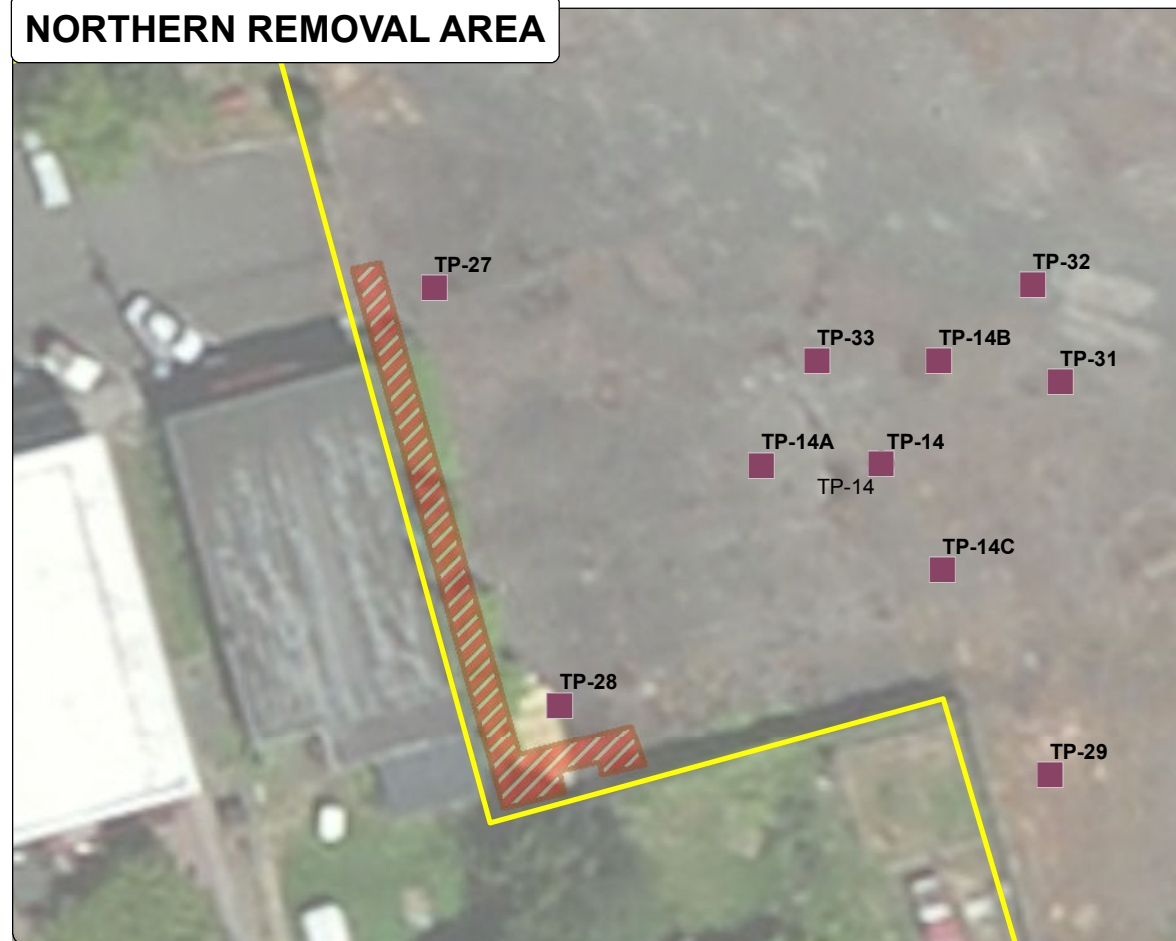
**Figure 4
Restricted Areas Detail**

LATHE PIT

BARKER AREA

TP-13/TP-13A

NORTHERN REMOVAL AREA

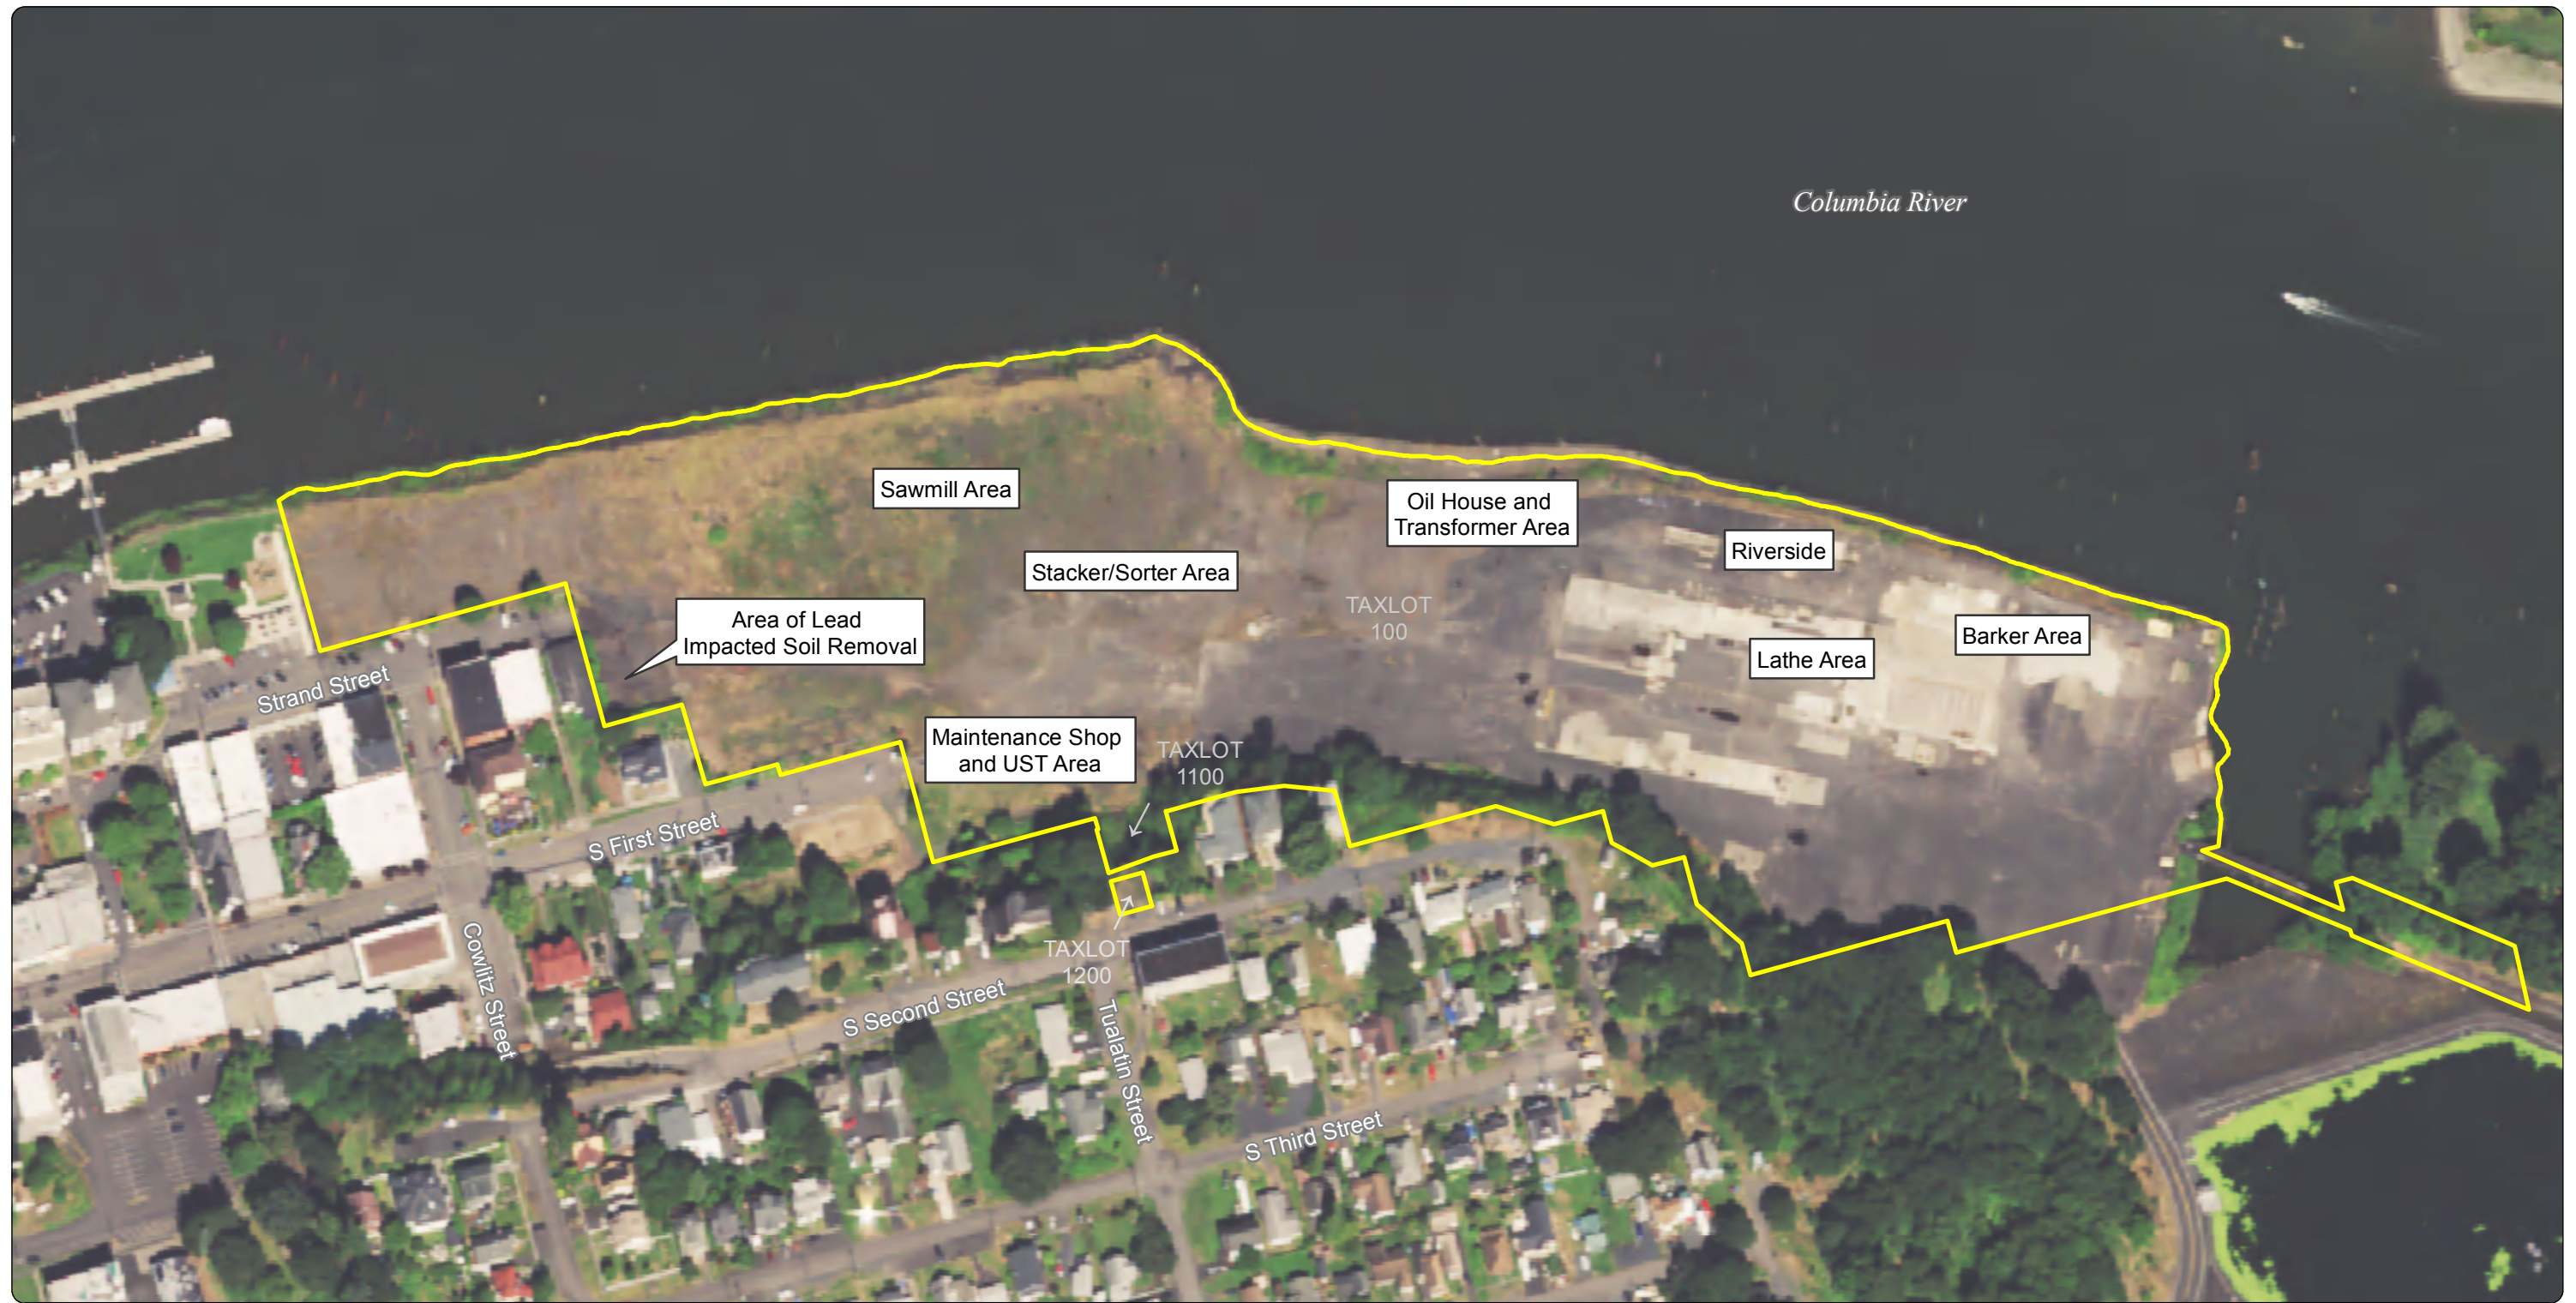
The CRECs identified through completion of this Phase I ESA are noted below and are discussed in further detail throughout this report. Figure 5 displays the area names used to describe different portions of the Property.

Source: Aerial photograph (2014) obtained from the National Agriculture Imagery Program (NAIP).
Note: All site features are approximate and historical.
OHW = Ordinary High Water.

Below is a summary of environmental conditions and prior investigation findings for the Property based on a review of the above documents. This summary references certain areas on the Property (named for the former use of the area), including the Lathe Area, Oil House and Transformer Area, Barker Area, Maintenance Shop and UST Area, Sorter/Stacker Area, Sawmill Area, and Riverside (see Figure 5). The future use of the Property is currently unknown. Where sample data were available for review, they have been compared to the DEQ risk-based concentrations (RBCs) for residential, urban residential, occupational, and construction and excavation workers (as applicable). The preliminary risk assessment prepared by Boise and ERM, and approved by ODEQ, noted that exposure of ecological receptors to shallow soil contamination was considered unlikely due to projected future use of the Property. Additional, potentially more stringent screening criteria may be applicable to the Property (i.e., criteria for the protection of surface water receptors).
